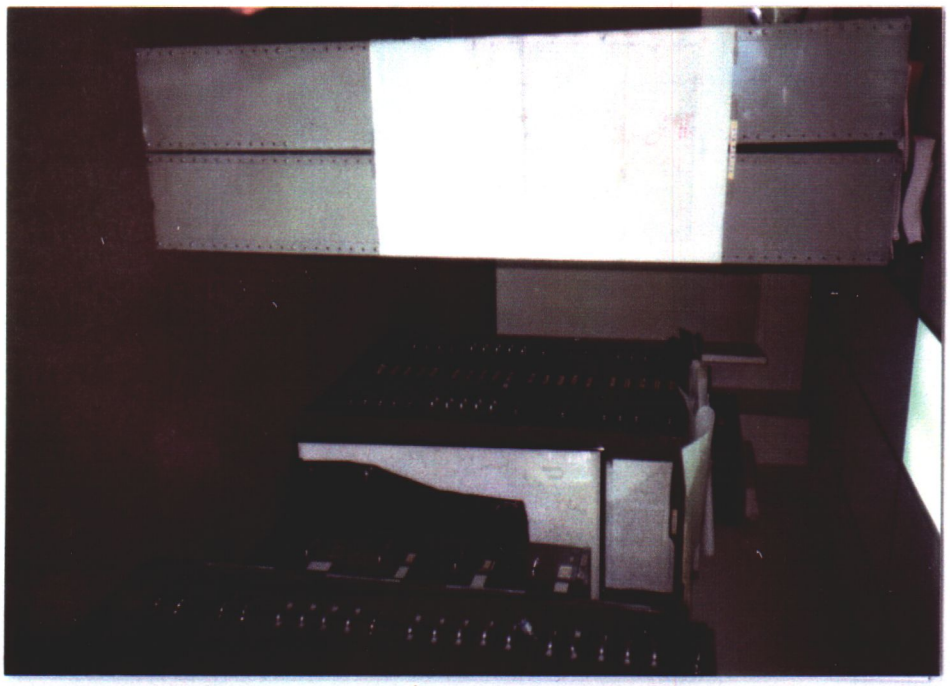
PHOTO # 11

ROOM 7025, SINGLE STACK OF MAP FILES, COE
HYDRAULICS BRANCH
